# Outcome of Retrograde Technique with Backfilling of Osteochondral Cysts: A Case Series

Jamey Allen, DPM; Raffaella Pascarella, DPM; Michael Theodoulou, DPM FACFAS

Department of Surgery; Division of Podiatry

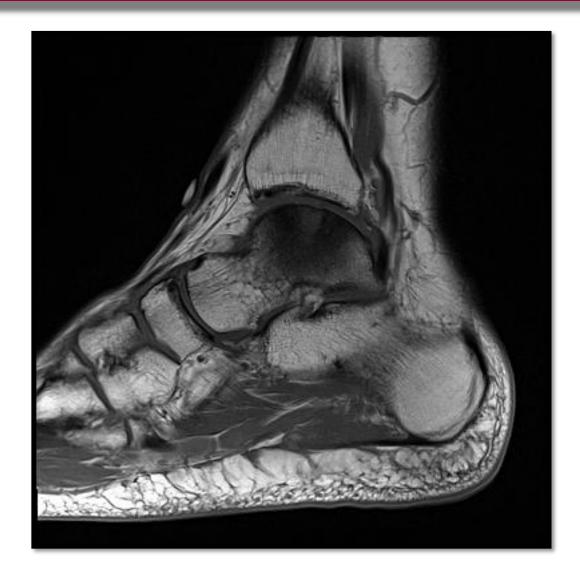
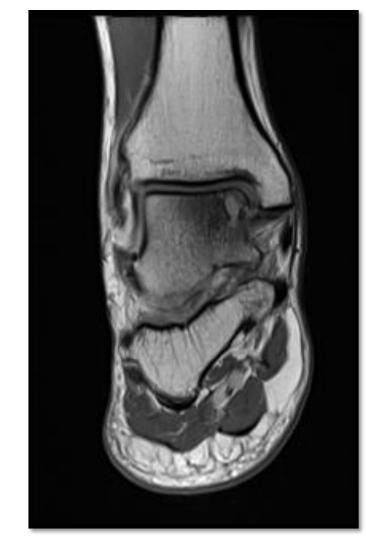
Image 1: MRI of a patient with the T1and T2 sagittal and coronal images depicting a central medial osteochondral cyst of the talus with an intact cartilage

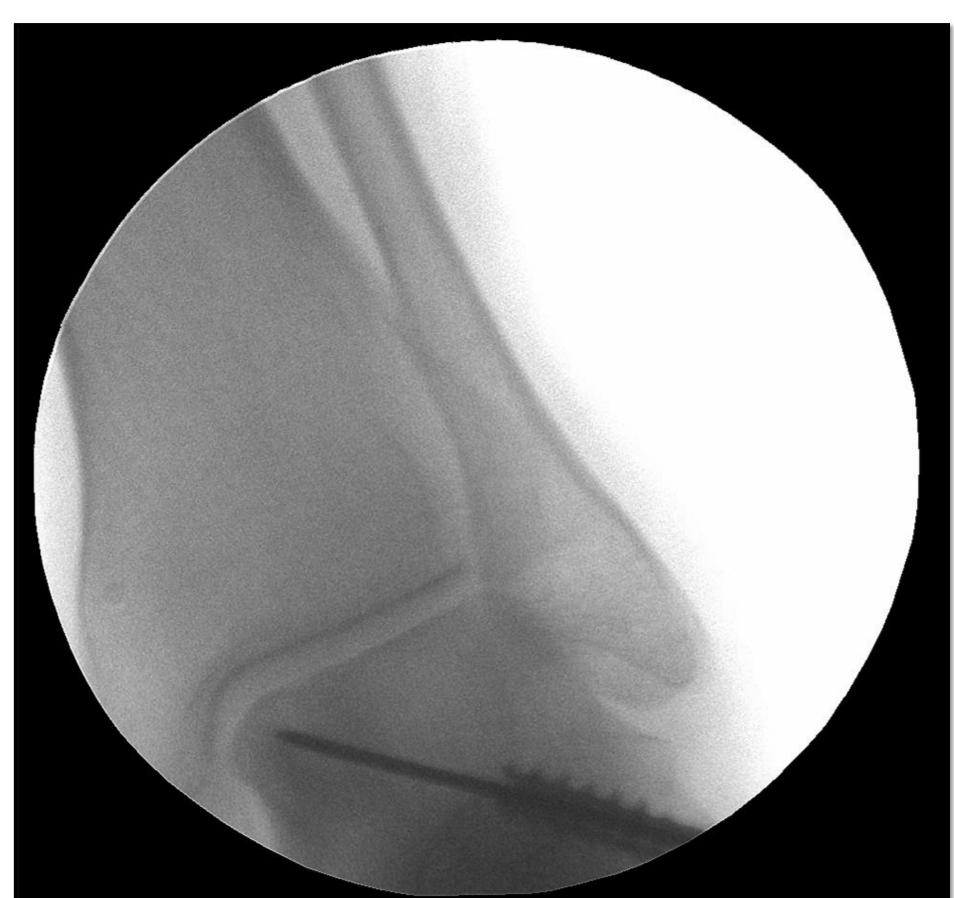
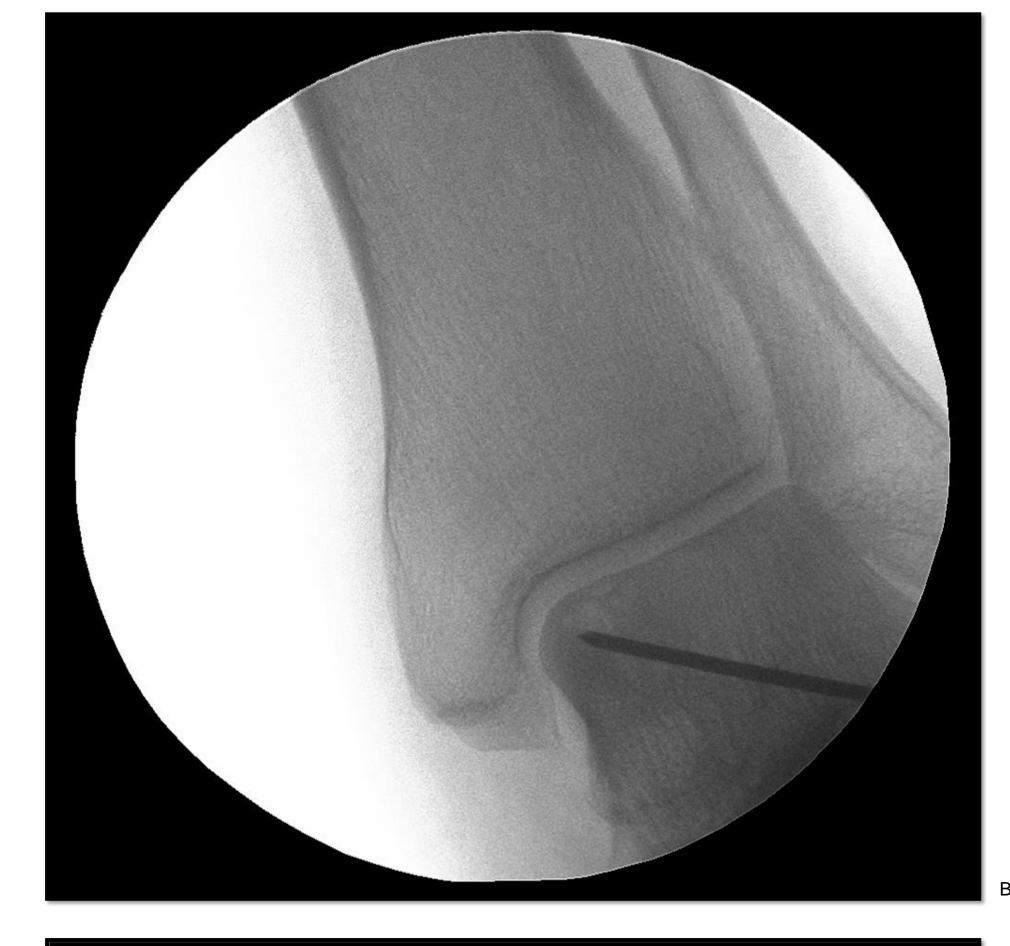
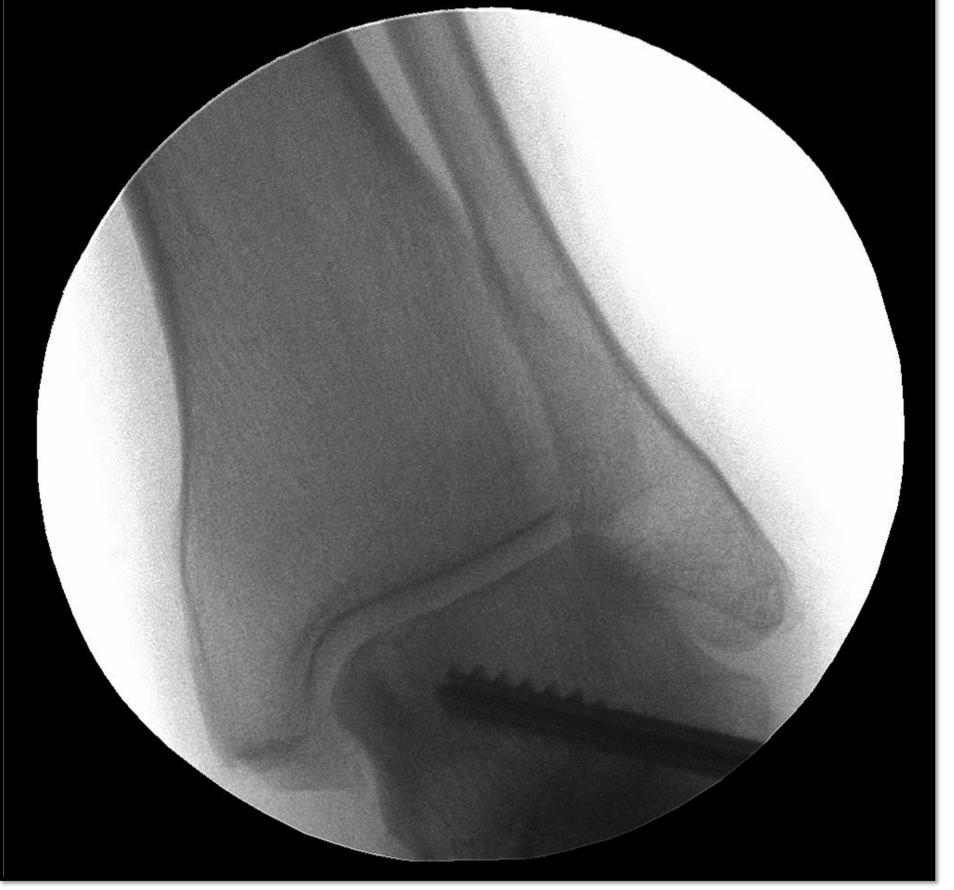
Image 2: A) Intra-operatively the talar cartilage overlying the osteochondral cyst appear intact B) A guidewire for a 4.5 or 6.7 mm screw is triangulated to the lesion utilizing fluoroscopic imaging C) The site is drilled for a 6.7 mm cannulated screw D) Screw is inserted and the guidewire is removed in order to introduce the injectable demineralized bone matrix through the screw using a large gauge spinal needle or angiocatheter.

Patients who suffered from ankle pain for a minimum of 6 months following an ankle injury underwent MRI. When an osteochondral cyst or defect within the talus was identified and conservative treatment failed, the patient underwent arthroscopic evaluation with the option for microfracture or backfilling of the defect. Intra-operatively, if the cartilage appeared adhered to the talar surface and was firm with palpation utilizing a probe, the patient would undergo the backfill procedure. If the cartilage was soft and peeling away from the subchondral plate, the patient would undergo a microfracture of the subchondral plate. Once the decision to backfill the cyst was determined, a guide-wire for a cannulated 4.5 / 6.7 mm screw was directed to the cyst under direct fluoroscopic visualization. Once the lesion was triangulated, the drill was advanced to the level of the cyst. Under fluoroscopic imaging, a 6.7 mm screw was inserted to the level of the cyst. Injectable bone substitute was injected through the cannulated screw to level of the cyst utilizing a spinal needle or angiocatheter. The bone substitute was injected as the screw was removed to fill the void of the screw as demonstrated by Image 2.
